Network
Testing &
Emulation
Solutions

GENERIC VENDOR NEUTRAL TESTING RESULTS

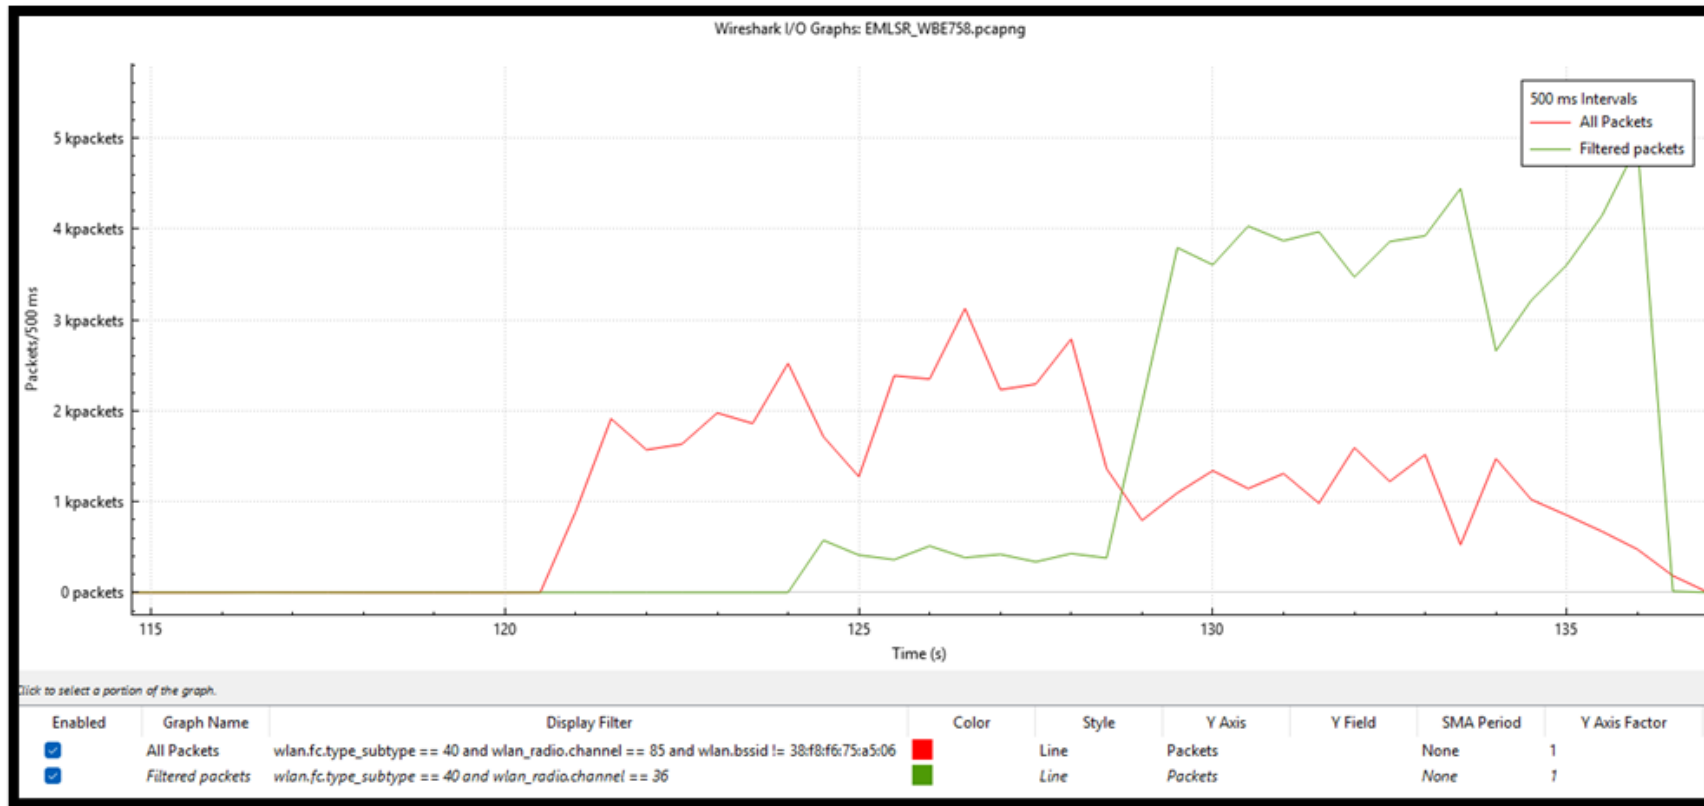
eMLSR Test

- We connected a client on the 6GHz band and triggered QoS traffic on it. Simultaneously, we introduced interference on the same 6GHz channel.
- Upon introducing interference, the link transitioned to 5GHz; however, the QoS data flow remained on 6GHz instead of moving to 5GHz.
- We also tested with the TP-Link Archer 800 and observed that link steering occurred as expected, with the QoS data flow on the steered band.

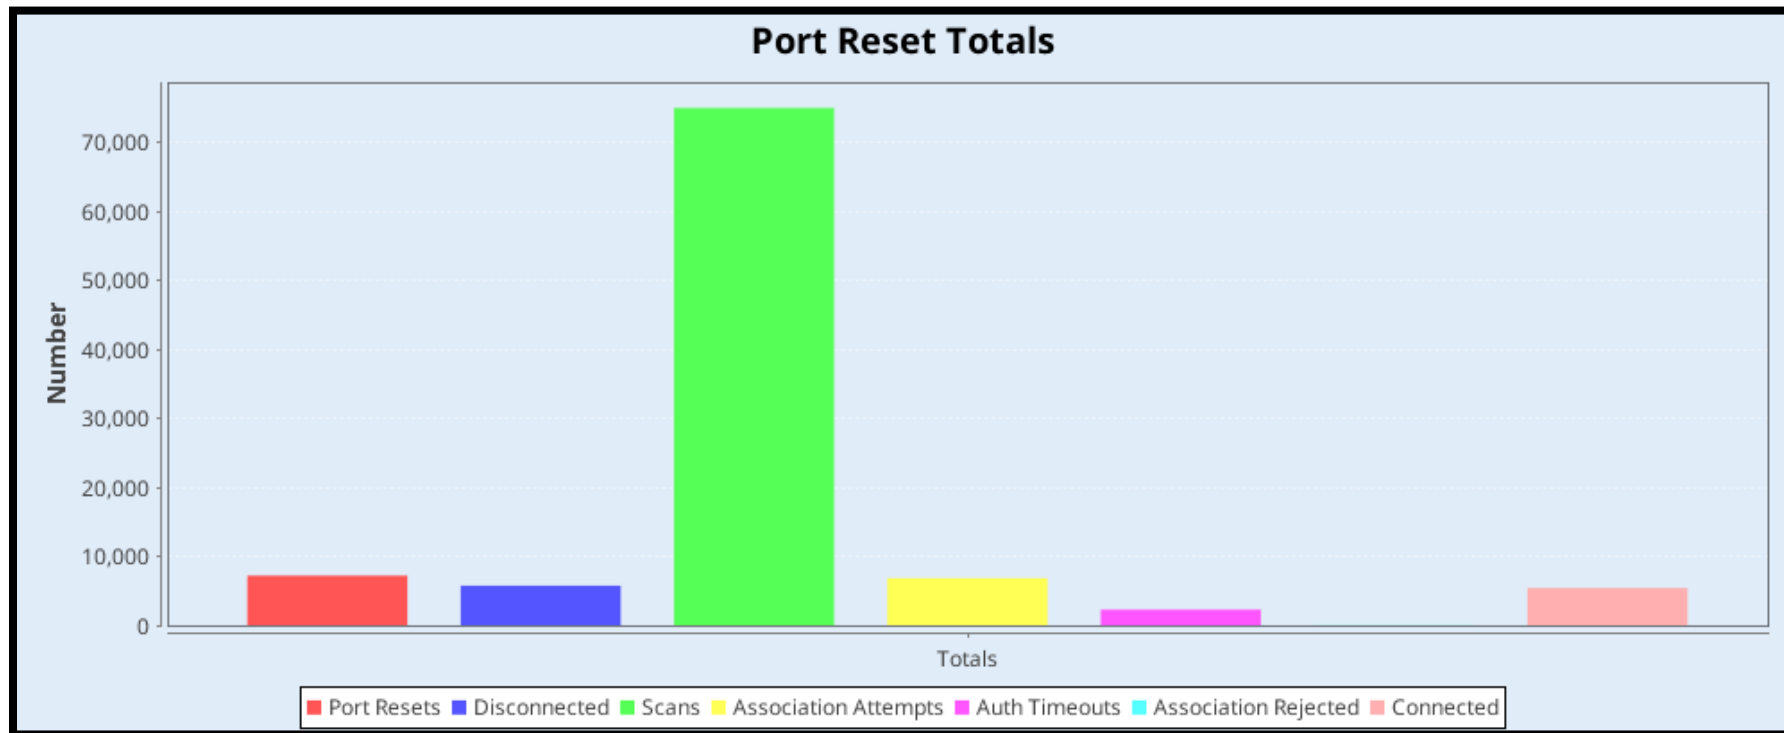
- A Port Reset Test was executed over a 12-hour duration with a concurrent port reset count of 50.
- A total of 7,200 port reset events were triggered during the test.
- Out of these, 5,401 resets successfully re-established connections.
- A total of 75,046 scan attempts and 6,822 association attempts. Despite these attempts, only 5,401 associations were successfully completed.

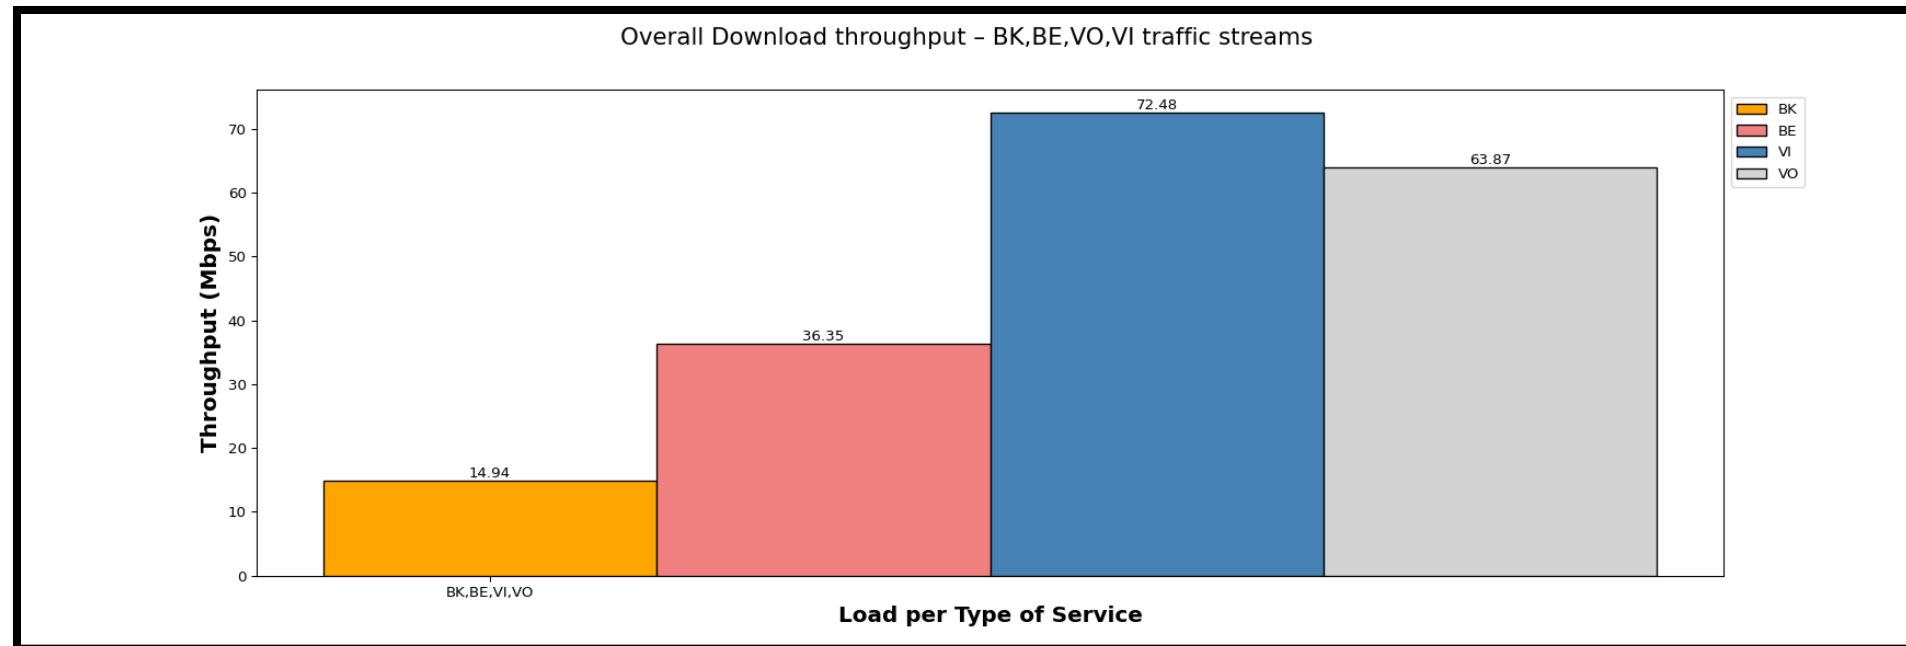
QoS Test

- A QoS traffic throughput test was conducted on 39 real devices to verify ToS bit prioritization across UDP and TCP protocols. Testing was performed in incremental order with 1, 5, 10, 20, 30, and 39 clients.
- With 1, 5, and 10 clients, QoS prioritization worked as expected, and no client disconnections occurred.
- However, with 20 or more clients, the prioritization was inconsistent, with Video (VI) receiving the highest priority, followed by Voice (VO), Best Effort (BE), and Background (BK).
- The Channel Utilization of 5G Band is 92% and 2G band is 94%.

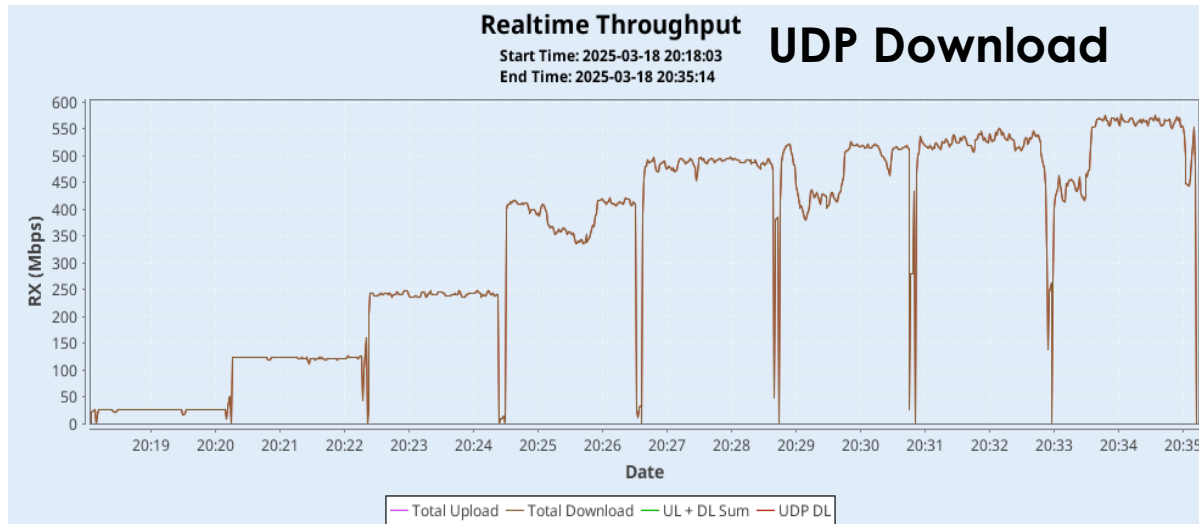
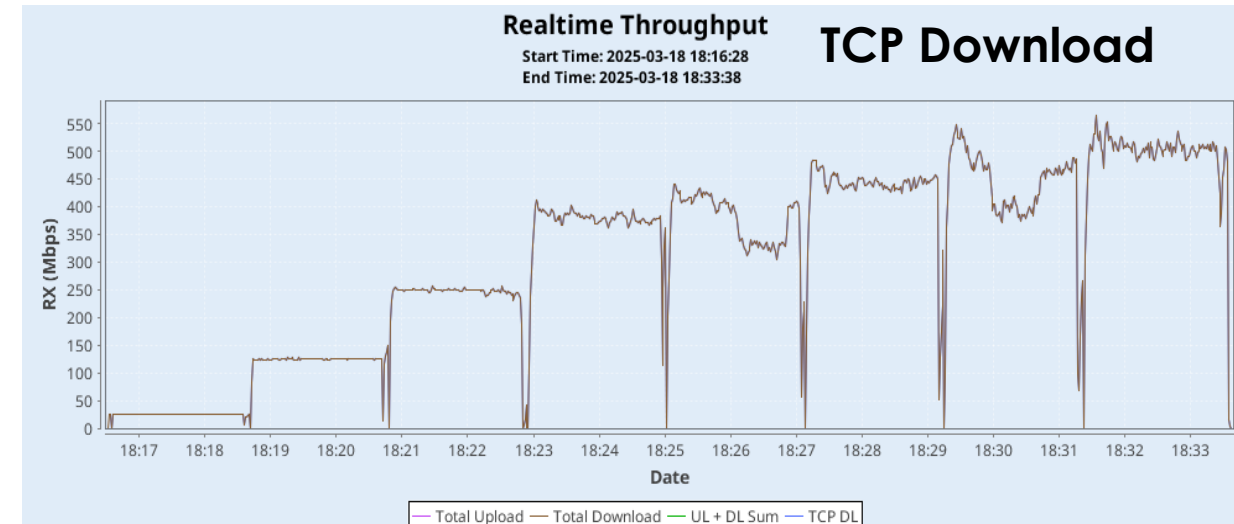
Throughput test with incremental client count

- The Throughput test was conducted on both download and upload directions using TCP and UDP protocols across various loads (10Mbps, 20Mbps, 25Mbps per client) with a total intended load of 1Gbps for 39 clients.
- A throughput drop of 80–100Mbps was observed at client increments of 25, 35, and 39 when running the Download traffic with both the UDP and TCP Protocols.

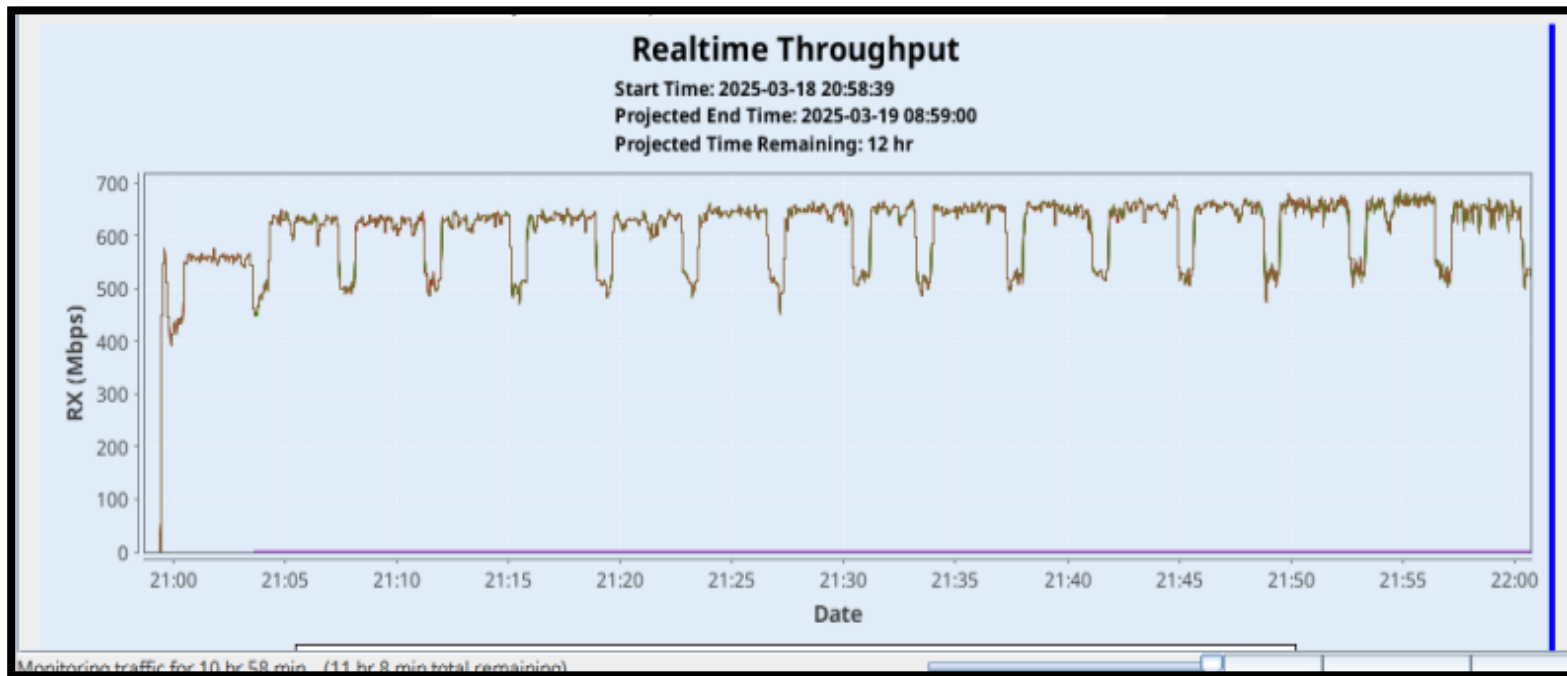
Stress Test

- Triggered a 12 hours Long run (Stress) test with 39 Real Devices (Mix of OS Devices) with Intended load of 1Gbps Where, 28 devices got connected to 5Ghz band and 11 devices got connected to 2.4Ghz band.
- During the 12-hour stress test, periodic throughput drops (around 100Mbps) were observed every 4 minutes.
- The Throughput attained after the completion was around 612Mbps. Due to these periodic throughput drop there was a significant impact on the throughput attained.

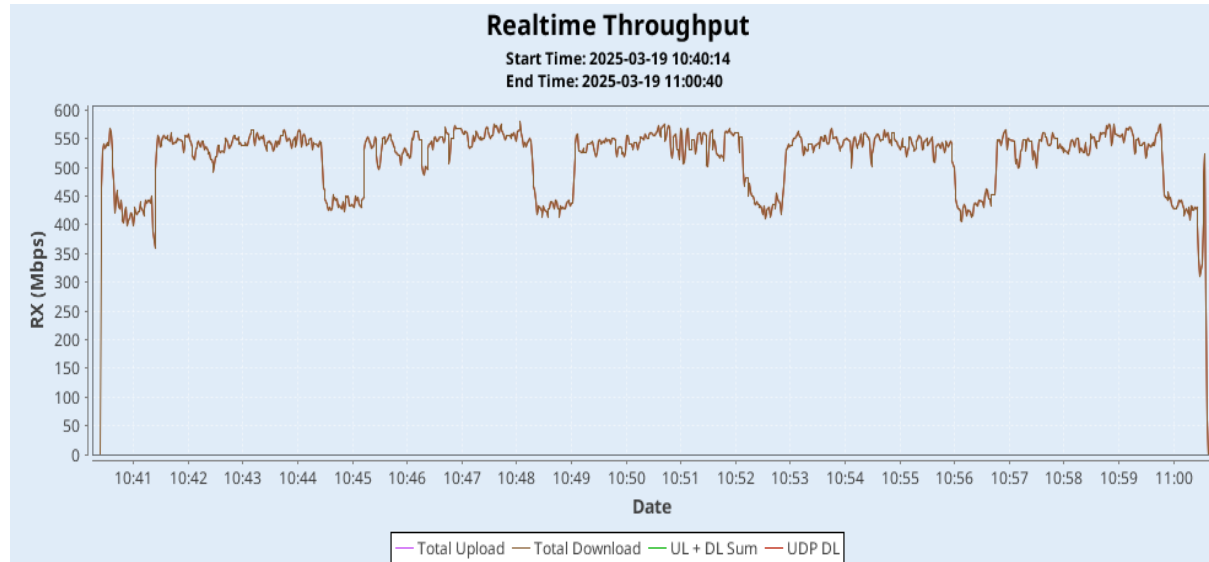
- To investigate further, a 20-minute test was conducted with the same load, and packet captures were analyzed. The I/O graphs indicate that at the points where throughput drops occurred, beacon packets were missing from the AP
- This issue is not client-specific, as it was observed across both AP models and was seen with both real and virtual clients, including tests with a single client.

Realtime graph showing periodic throughput drops

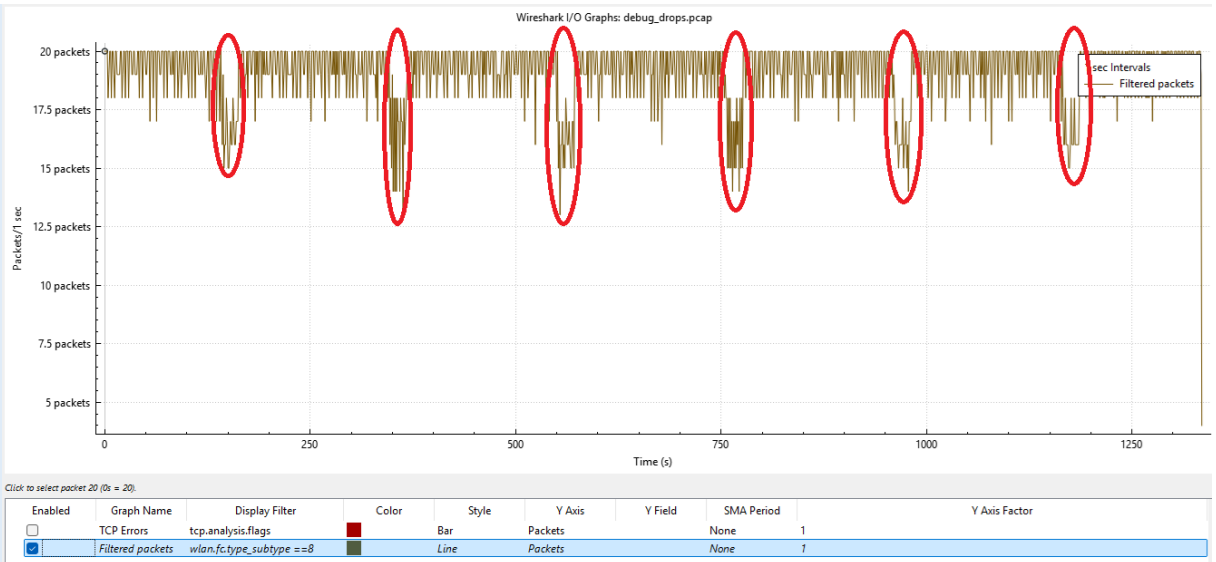
I/O graph indicating beacon packets lost from the AP side

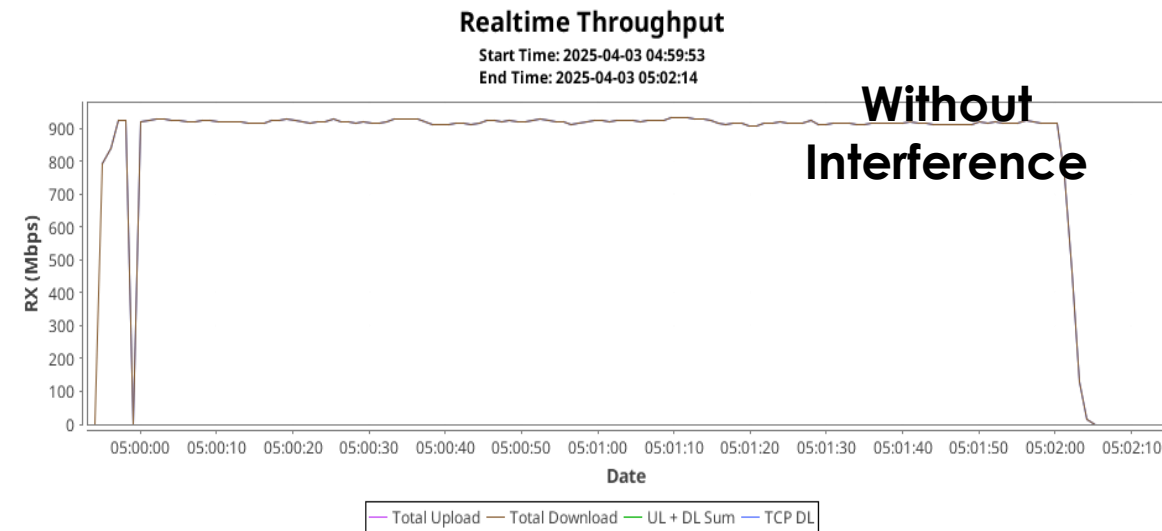
- The Preamble Puncturing test was conducted to evaluate whether the Device Under Test (DUT) AP can effectively utilize the remaining non-punctured bandwidth when interference affects specific portions of the spectrum. Testing was performed on both the 5 GHz and 6 GHz bands.
- Without interference, when the client is connected to the 5 GHz band, the achieved throughput is approximately 915 Mbps. We observed that throughput performance degradation under interference was significantly lower compared to ideal conditions.
- When the Station (STA) initially associates with the Access Point (AP) and a throughput test is conducted in the absence of interference, data transmission is occurring over the full 80 MHz channel bandwidth.

- With interference, the 20 MHz subchannel (channel 44) within the 80 MHz allocation should be excluded from transmission. This should be reflected in the Punctured Channel Information field of the QoS Data frame, which should be set to 0x03, indicating that channel 44 is punctured. However, the observed behavior of this DUT does not align with expectations.
- Even under interference, the **EHT Operations Field**: The "Puncturing Bitmap" in the Beacon Frame was set to **"False,"** indicating that no 20 MHz channel was punctured.
- Additionally, in the **QoS U-SIG Field**, the U-SIG field in the QoS frame displayed **"00 000,"** indicating **"Punctured Channel Information: 0x00"**.

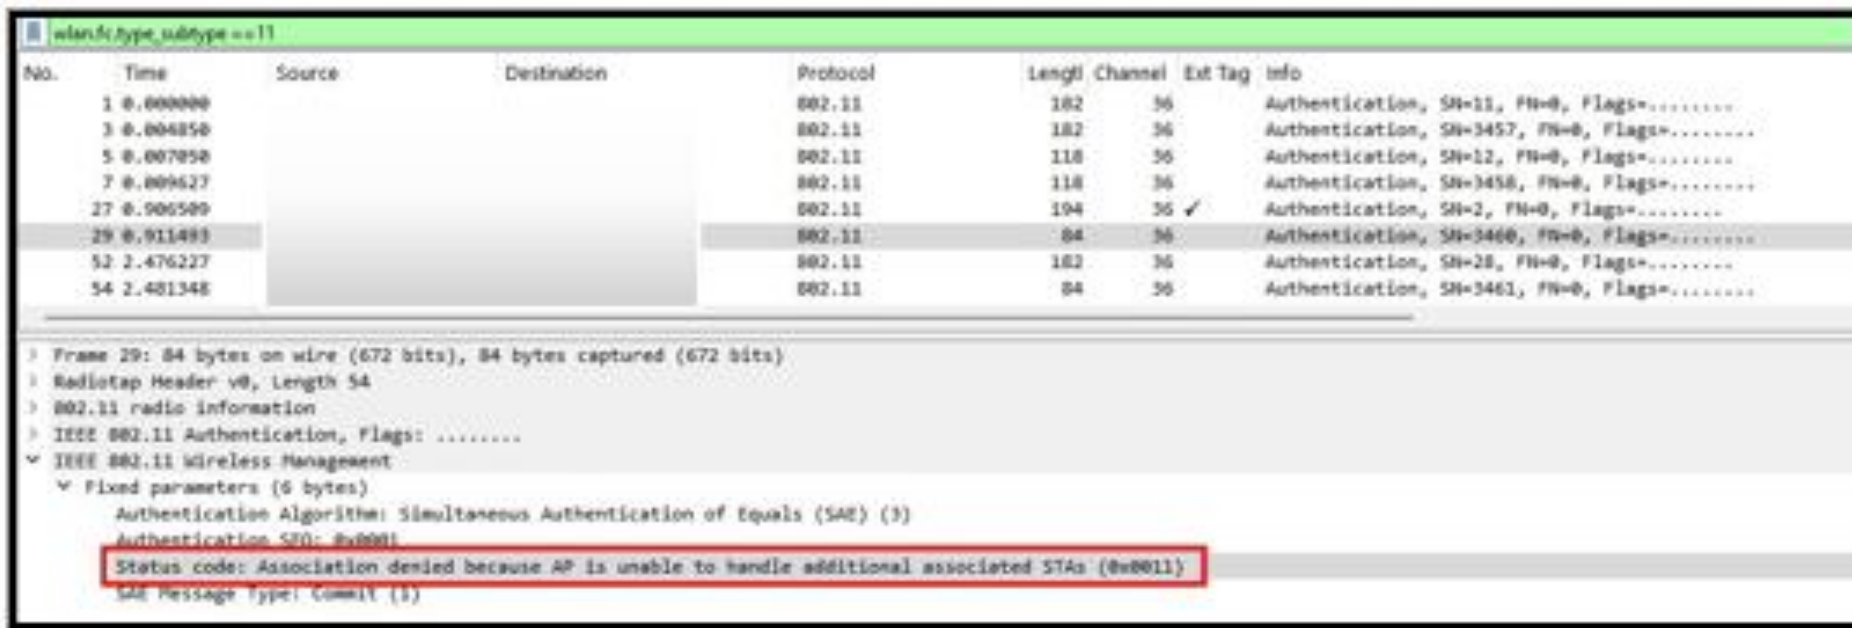
Load Balancing Test

- **Load Balancing with Maximum Number of Clients per Radio Enabled:**
 - Thresholds were set as follows: 2.4 GHz-15 clients, 5 GHz Low: 20 clients, 5 GHz High: 20 clients and 6 GHz: 10 clients.
 - Initially, 13 clients connected to 2.4 GHz, 31 clients to 5 GHz, and 1 client to 6 GHz.
 - Once the 2.4 GHz band reached 15 clients, additional clients were denied with the expected message: "Association denied for 1c:c1:0c:36:1d:f8 as maximum client count reached on 2.4 GHz."
 - However, on the 5 GHz band, despite only 7 clients being connected, no additional clients were able to associate. AP logs and packet captures displayed the following message: "Status code: Association denied because AP is unable to handle additional associated STAs (0x0011)."

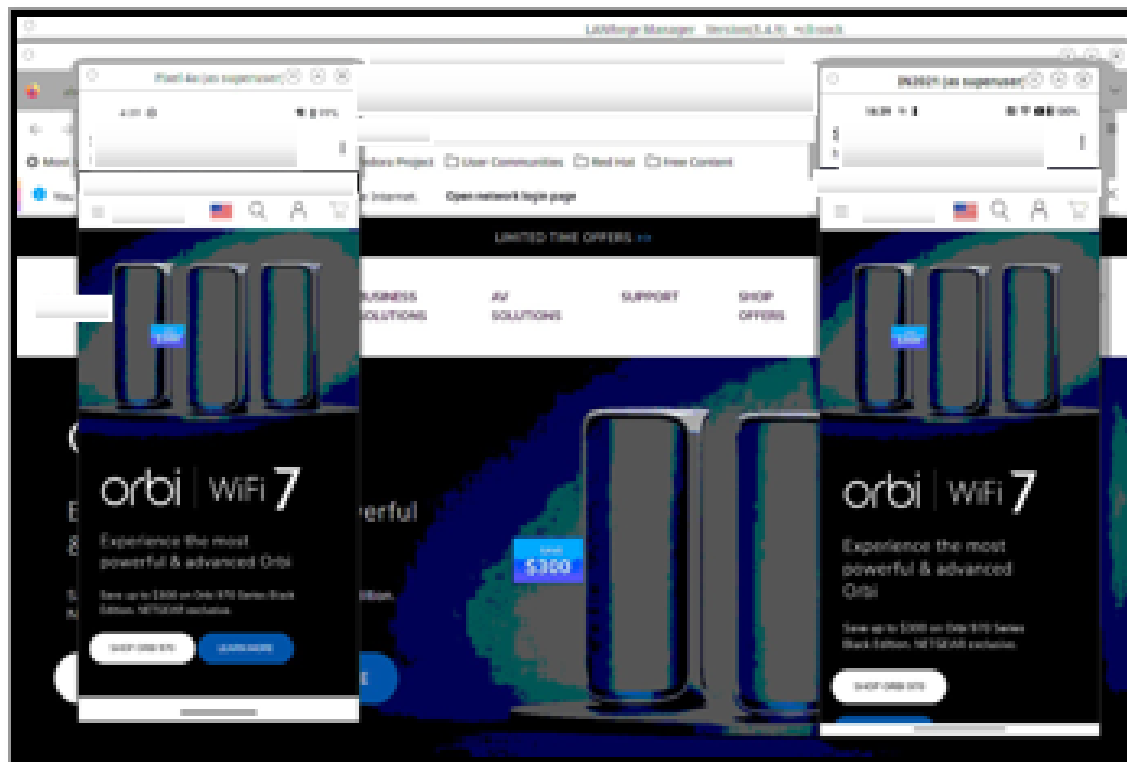
When the required splash URL was included in the Walled Garden, clients were able to access the URL directly

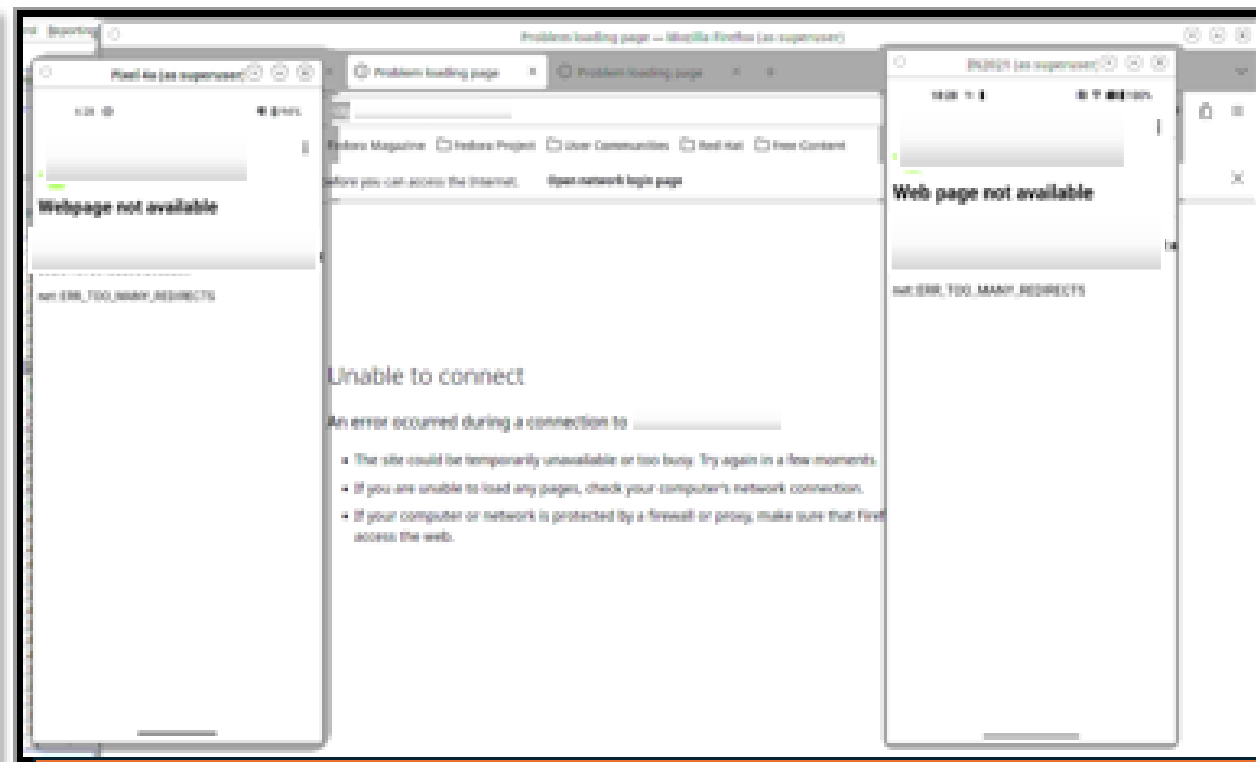
- Virtual clients failed to trigger a login popup and instead showed a “Unable to connect” error.
- As a result, when the splash page URL was not part of the Walled Garden, both real and virtual clients were unable to access the internet, and the expected login page was not presented.

When the splash page URL excluded from the Walled Garden, both real and virtual clients were displayed a "Sign in to network & Unable to connect" prompt, and the expected login page was not presented.

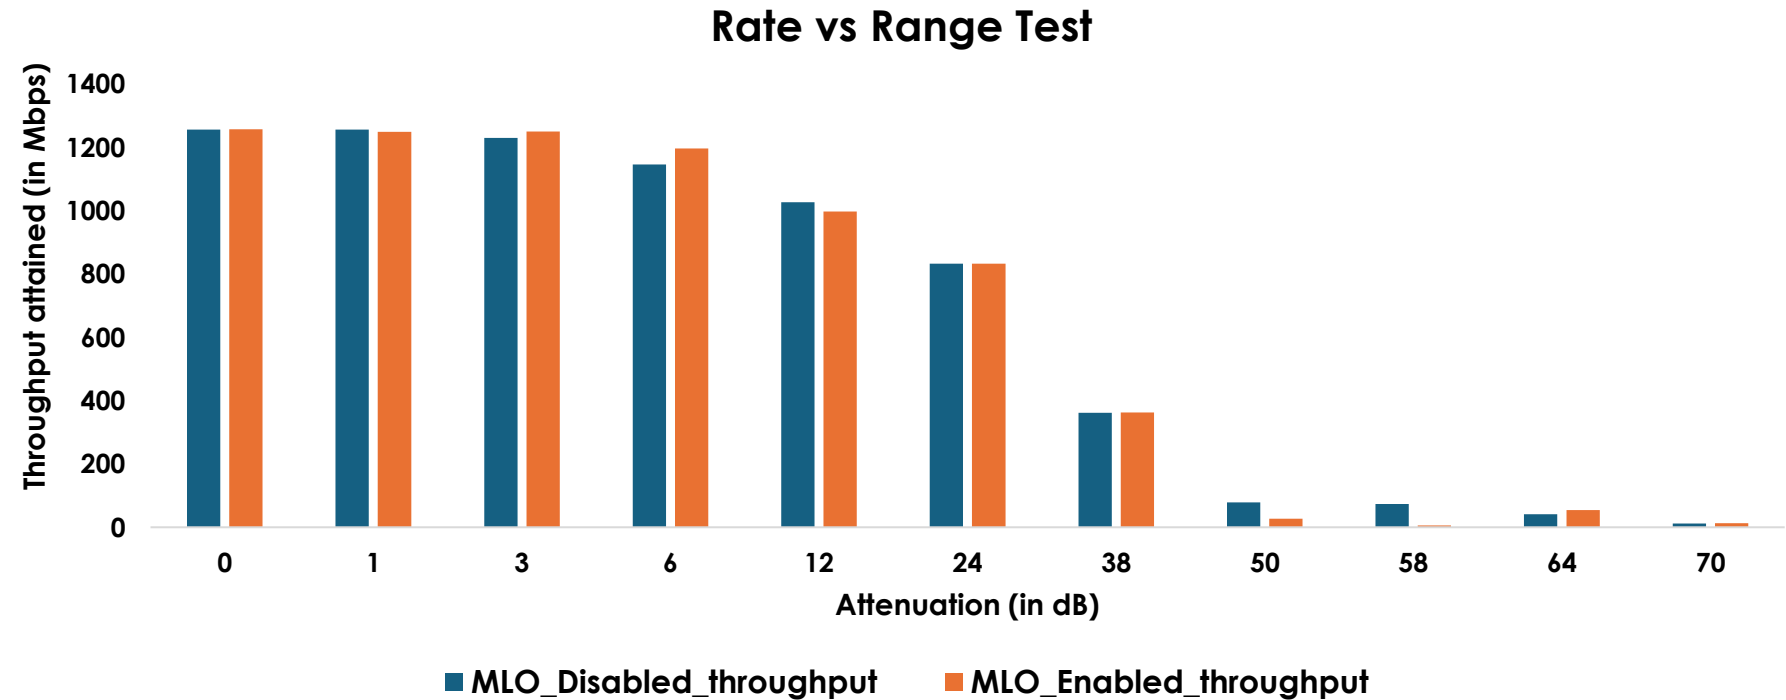
Rate vs Range

- RvR (Rate vs Range) testing was conducted under both MLO-enabled and MLO-disabled configurations. The throughput comparison graph illustrates performance across various attenuation levels: 0, 1, 3, 6, 12, 24, 38, 50, 58, 64, and 70 dB.
- The results indicate that enabling MLO did not result in significant throughput improvements compared to the non-MLO configuration. Throughput remained largely consistent across all attenuation levels in both modes, with no notable performance gains observed when MLO was enabled.

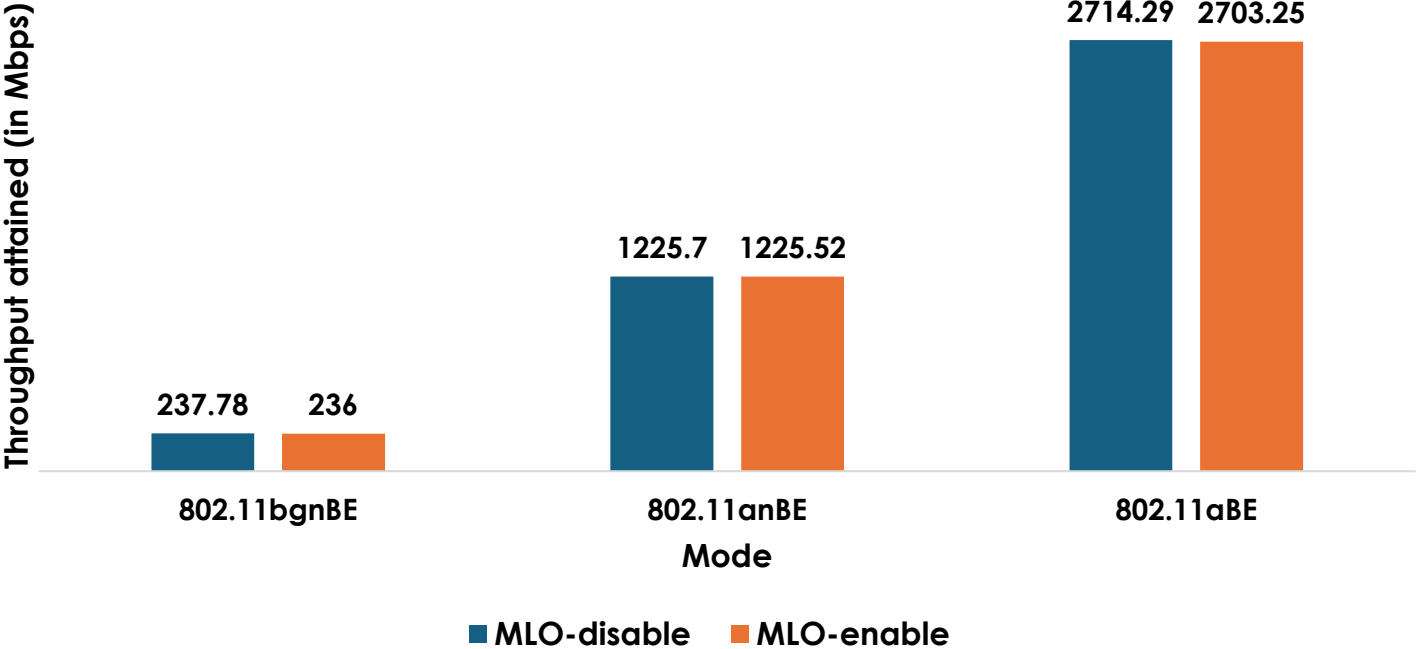
Dataplane Test

- Data plane test was conducted under both MLO-enabled and non-MLO configurations. The tests utilized MTU-sized packets over best-effort (BE) traffic across **bgn**, **an**, and **a** modes.
- The results show that enabling MLO did not provide any measurable improvement in throughput compared to the non-MLO setup.
