Network
Testing &
Emulation
Solutions

GENERIC VENDOR NEUTRAL TESTING RESULTS

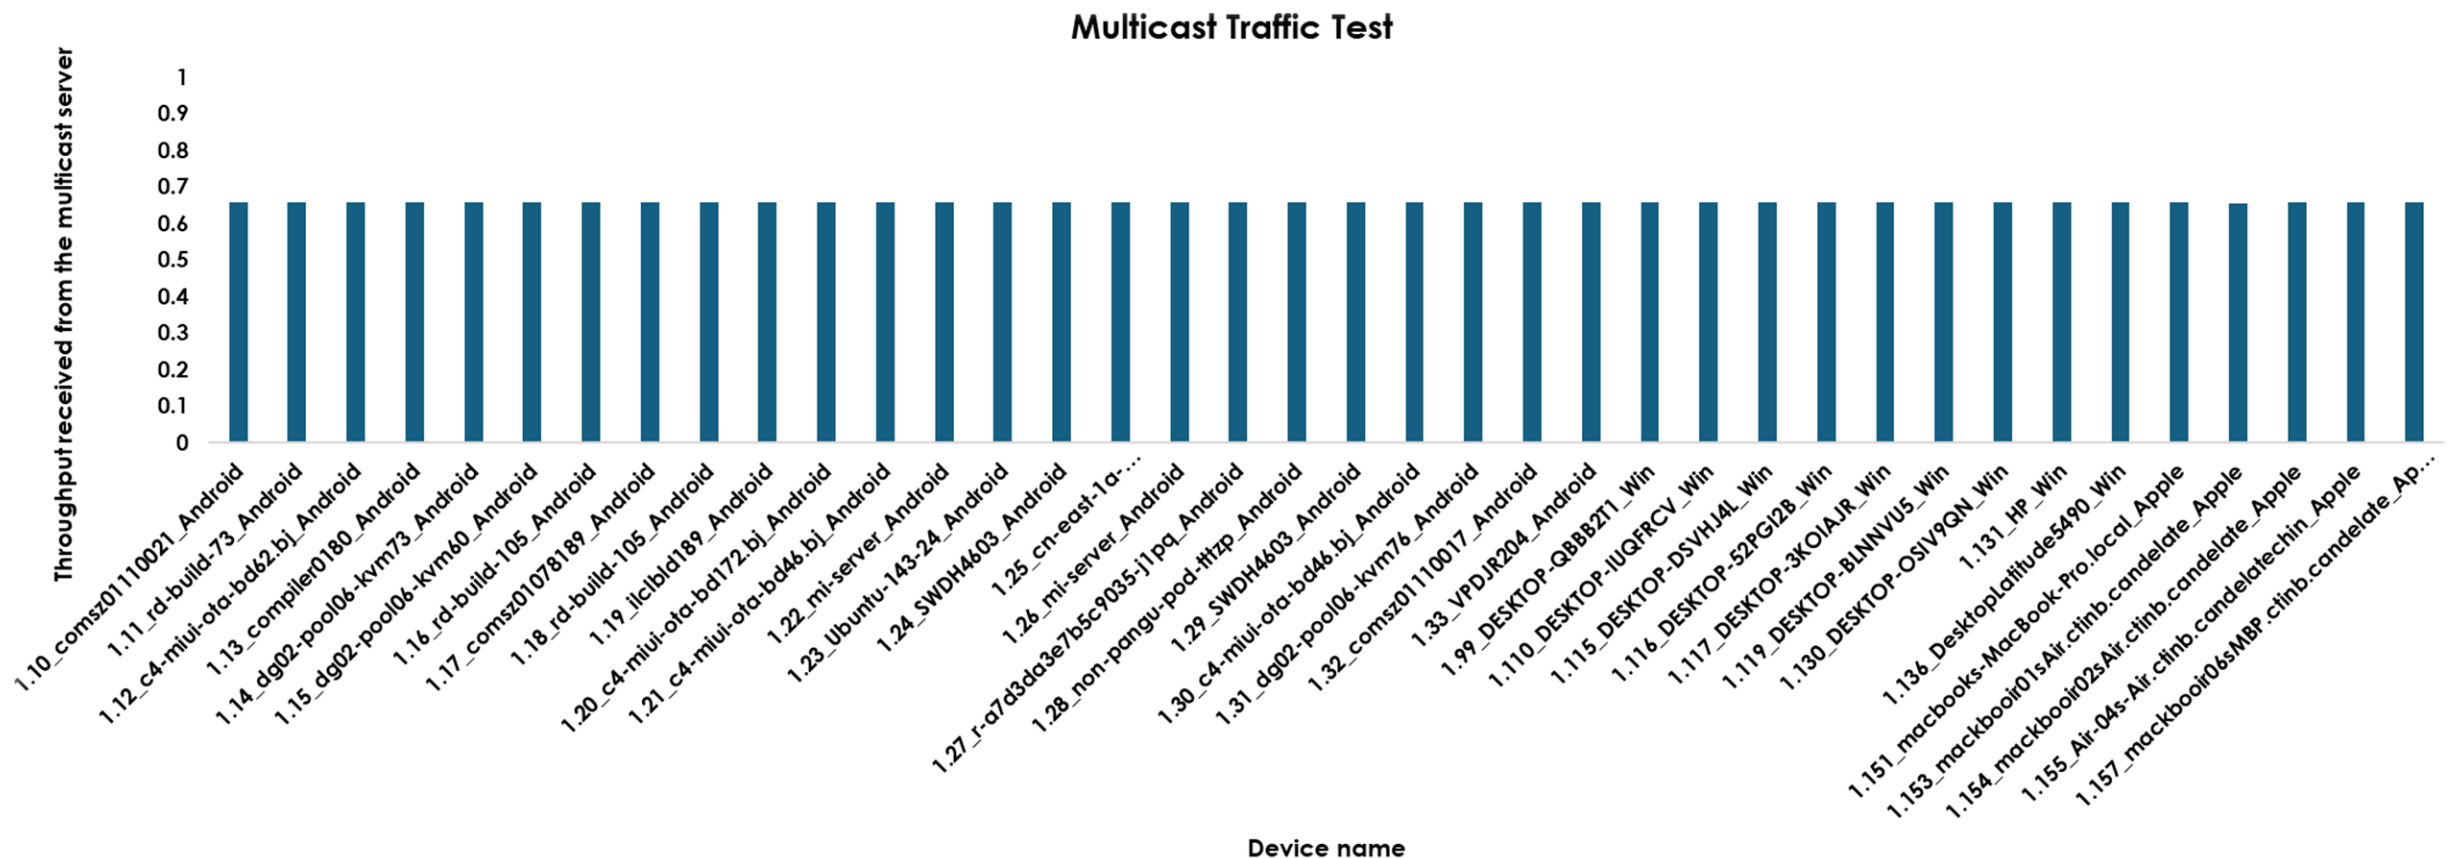
- By Creating a Multicast server of Intended load 25Mbps on Upstream port performed the Multicast traffic on all the OS devices (Android, Windows and MacBook).
- All 39 clients were able to receive the traffic as expected from the Multicast server and there were no client disconnection observed during the test.

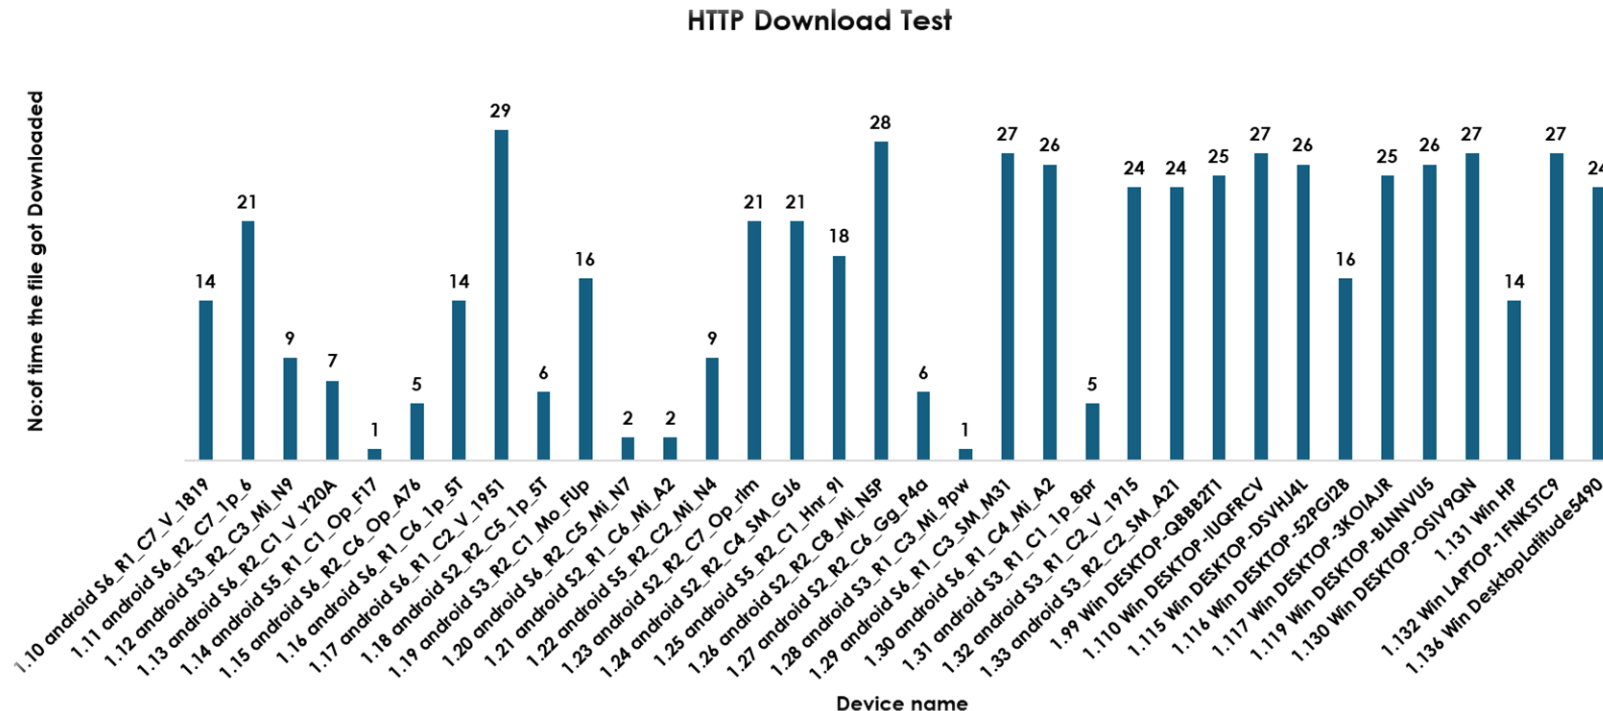
HTTP Download Test

- We have executed HTTP Download test with file size 25Mbps on all the Real devices (Androids, Windows, and MacBooks) individually for a duration of 5 mins.
- All the 34 devices connected to 5Ghz and 2.4Ghz band were able to download the 25Mbps file in the 5mins duration. However, 8 clients downloaded the 25MB file less than 10 times, unlike the other devices.
- All the devices remained to be in Connected state throughout duration of test.

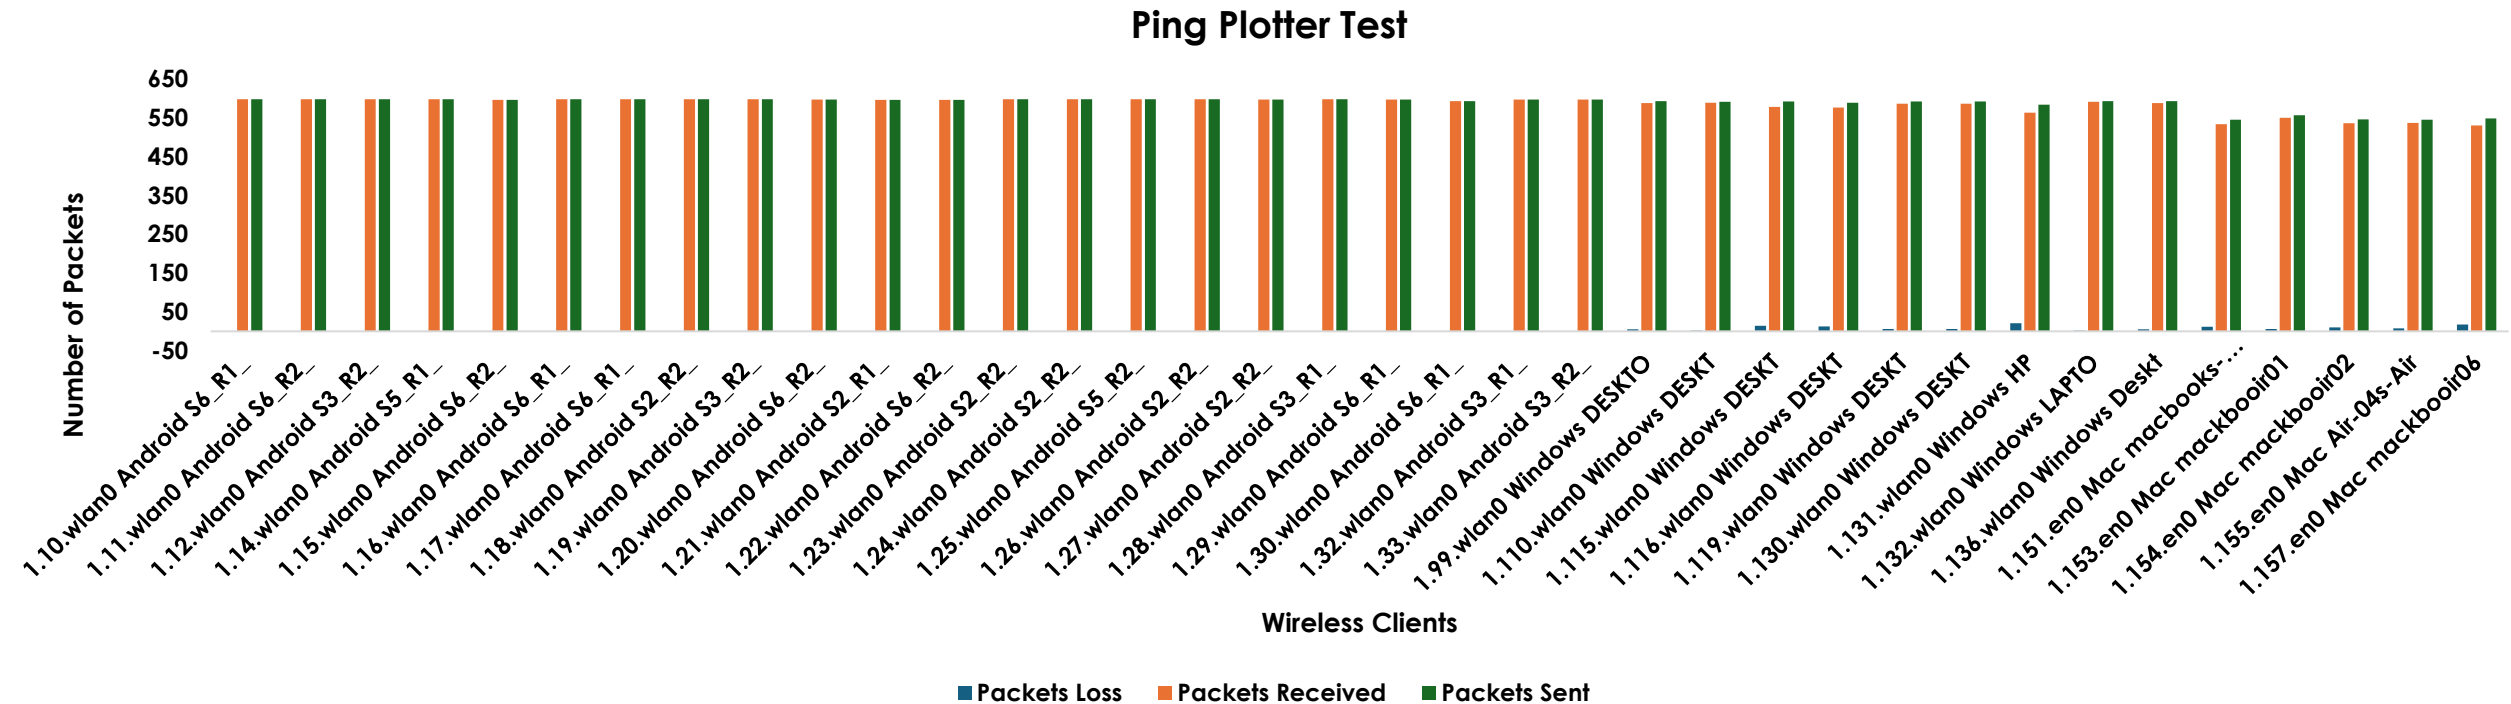
Ping Plotter Test

- We executed a Ping Plotter test to assess network connectivity for specified clients by measuring the round-trip data packet travel time while pinging www.mi.com for a duration of 10 minutes with 36 devices.
- Throughout the test, we collected data on client status, packets sent, packets received, and packets dropped.
- Out of 36 clients, 4 experienced packet loss ranging from 12 to 21 packets. However, all clients remained connected throughout the test duration.

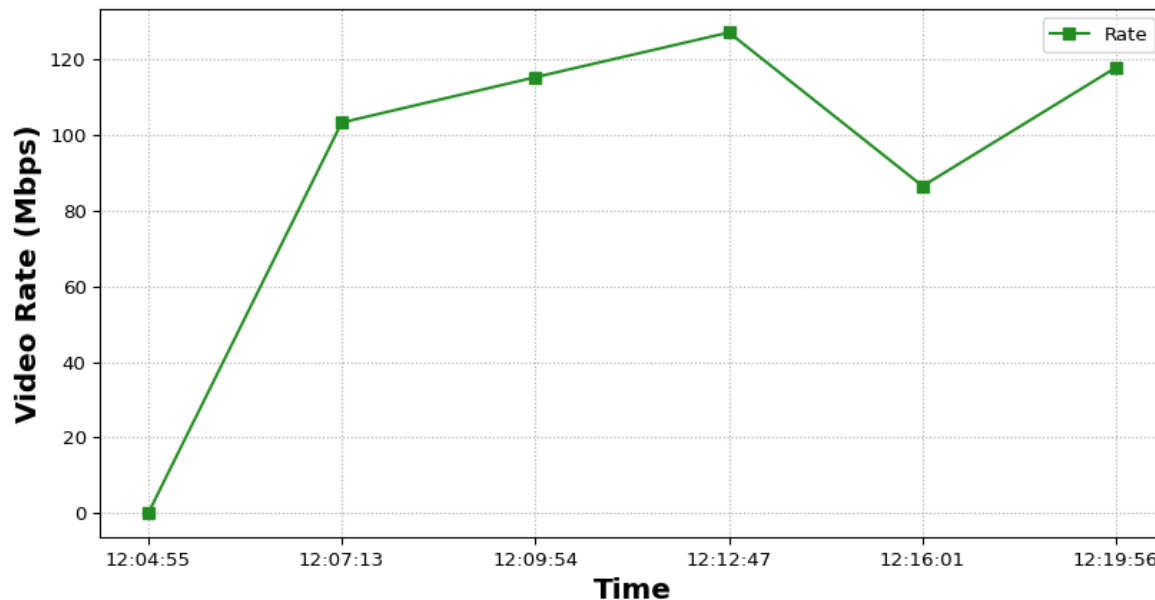
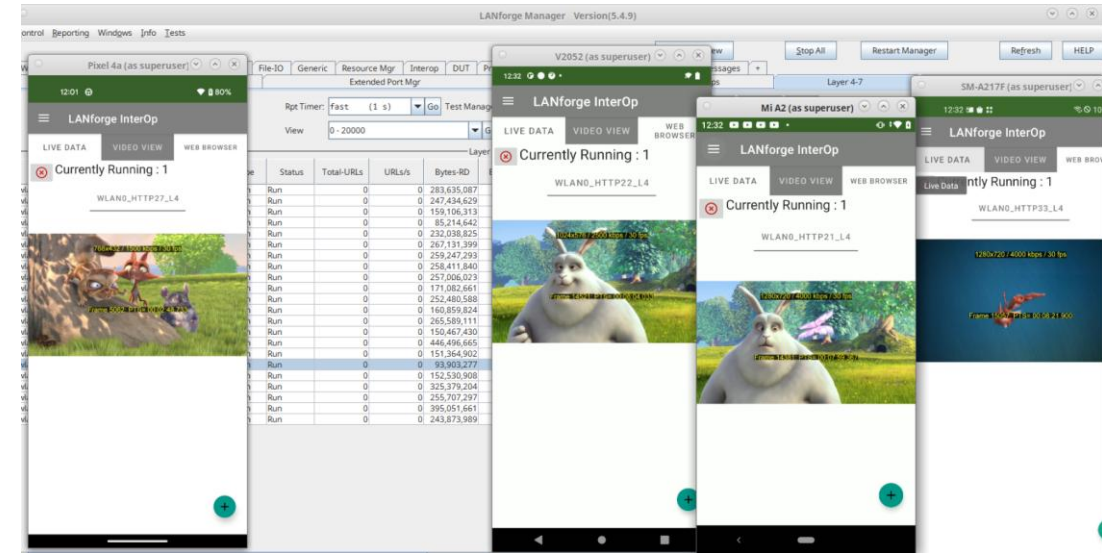
Video Streaming Test

- We have Conducted a video streaming test on all Android devices using the Dash Media source for 15 minutes to evaluate access point performance and stability.
- Measured parameters include the number of buffers, wait time, per-client video bitrate, and video quality.
- All clients streamed the video as expected; however, 4 out of 23 clients could not complete the video within the given duration, resulting in a reported URL value of 0 for those devices.

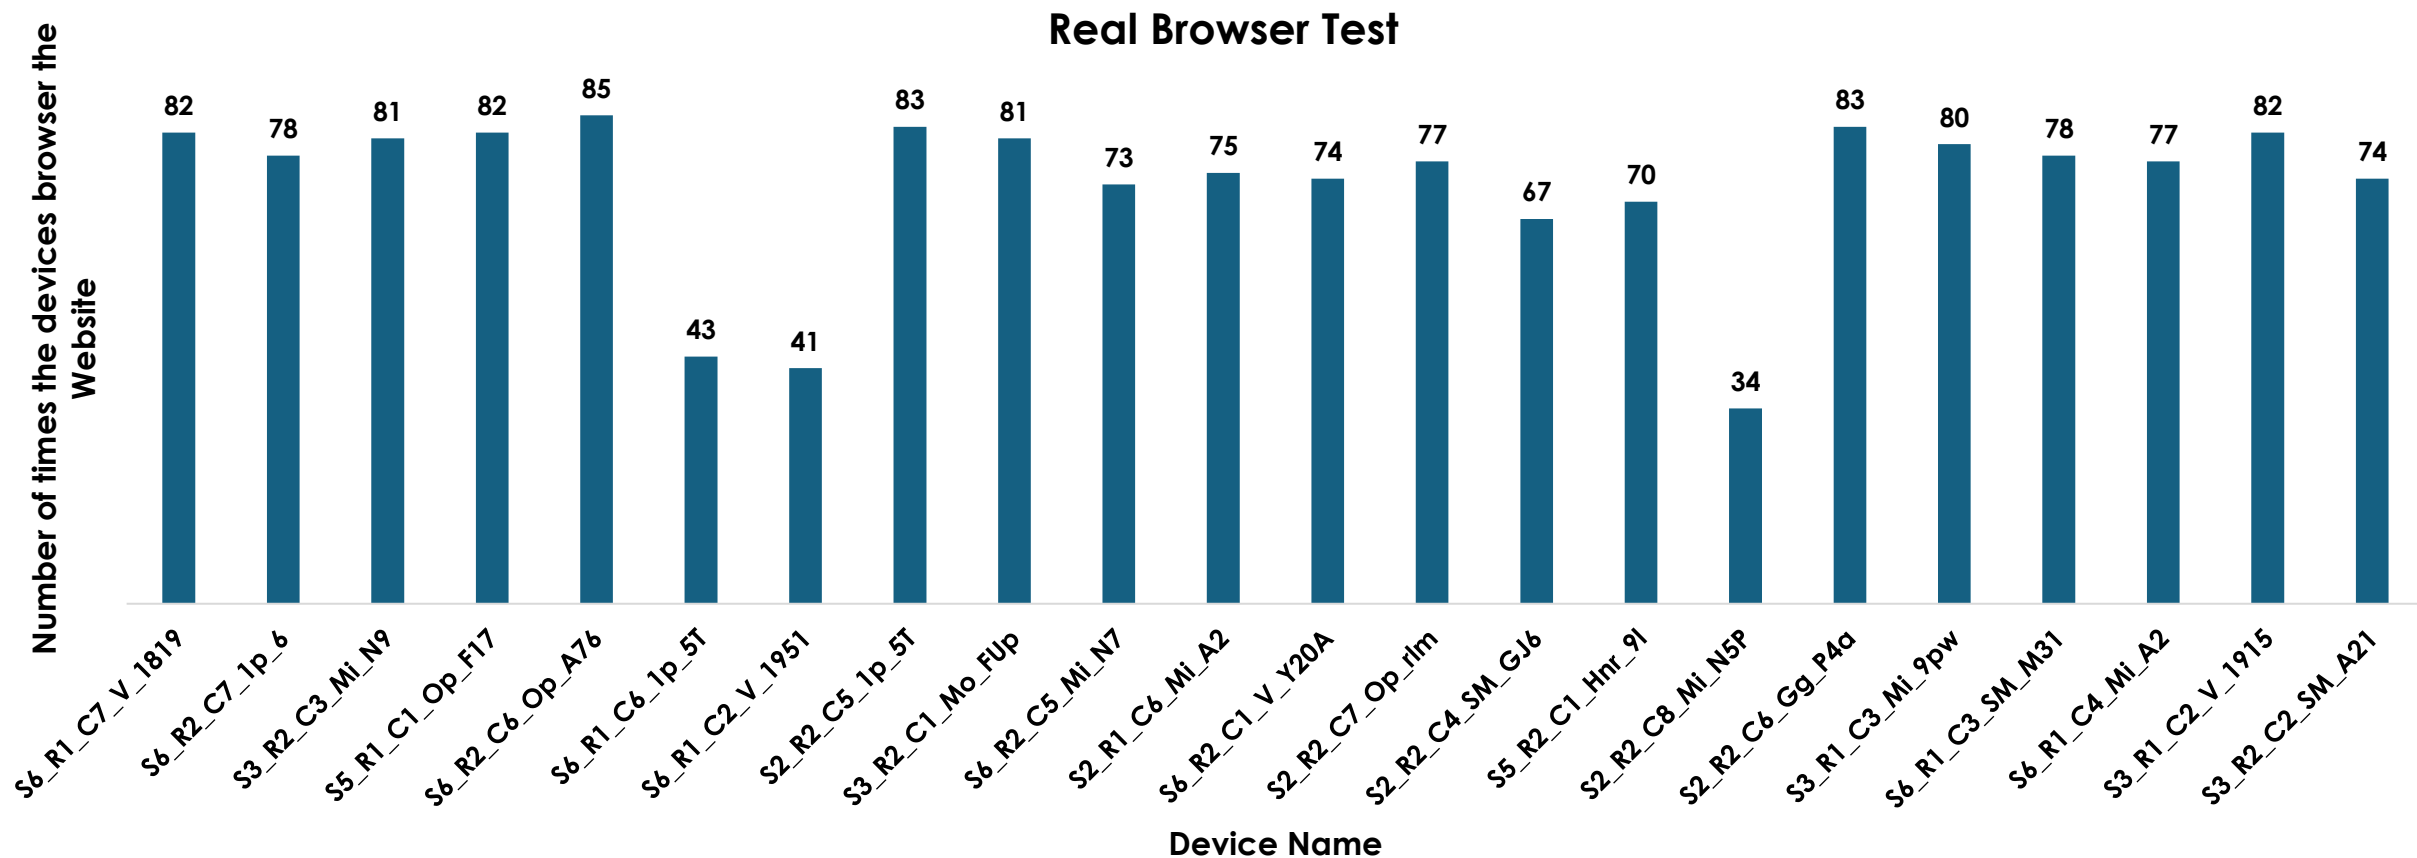
Real Browser Test

- We have Conducted a Real Browser test on all Android devices and browser a website www.mi.com for a duration of 10mins.
- All the 22 Android devices were able to browse the website provided as expected and there were no client disconnections seen throughout the test duration.

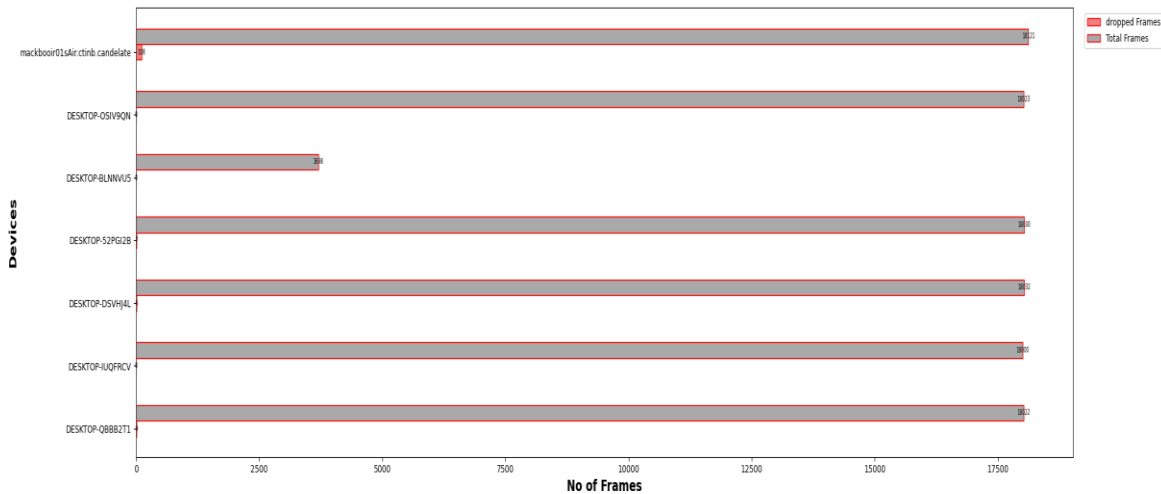
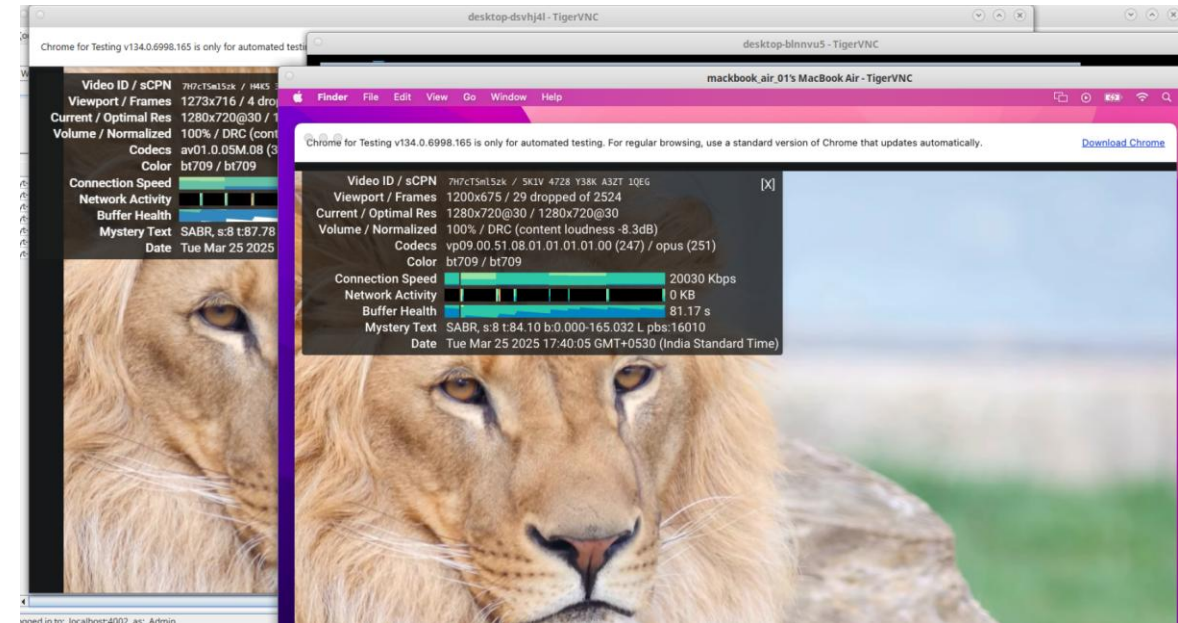
YouTube Streaming Test

- We have Conducted a YouTube streaming test across multiple laptops by providing a YouTube URL and set the resolution to 720p for a duration of 10minutes.
- When the YouTube video is playing on the laptop devices, we have collected key statistics such as video resolution, buffer health, total frames, and dropped frames throughout the test duration.
- There were no significant drops seen throughout the test and the buffer health of each device is consistent.

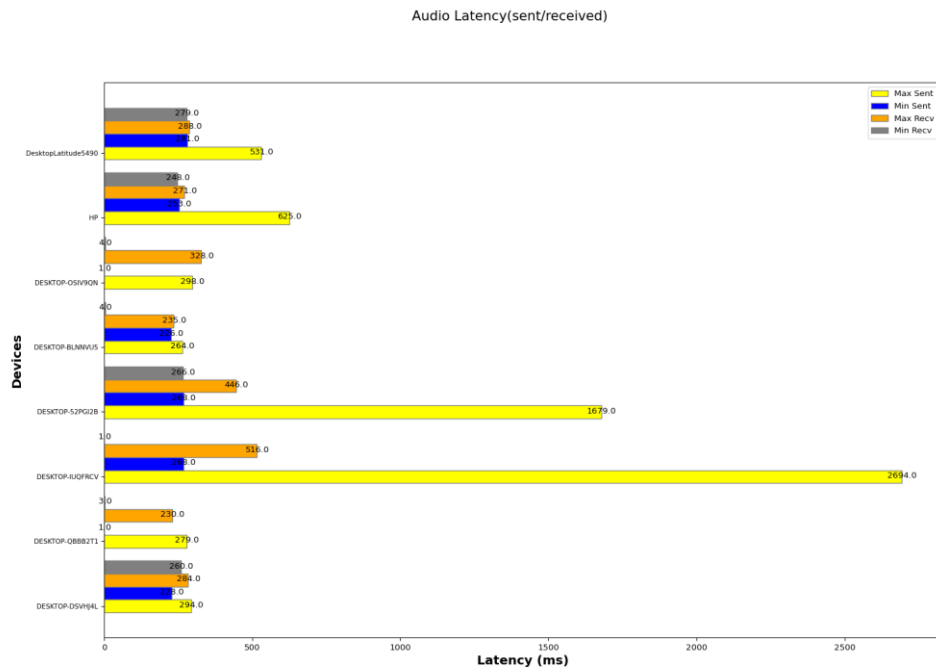
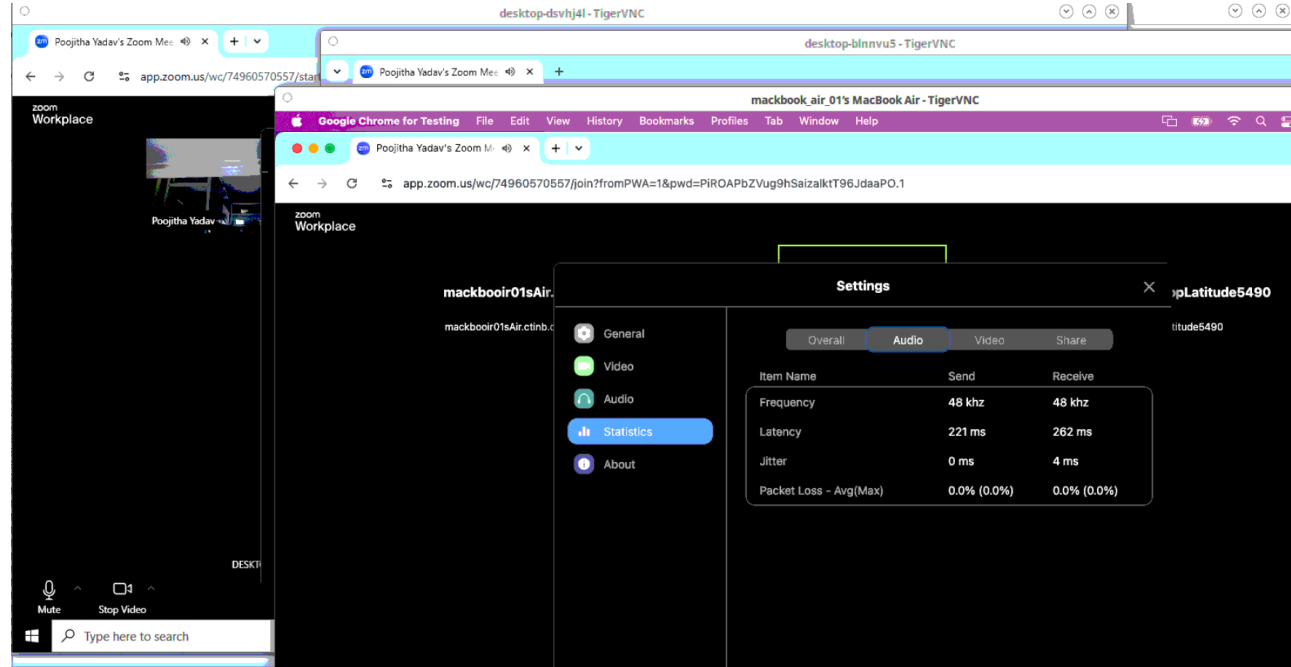
Zoom Call Test

- We conducted a Zoom call test across multiple laptops, selecting one device as the host and the others as clients. The test was performed for a duration of 10 minutes.
- Once the Zoom call test started on the laptops, we collected key statistics on the performance of audio and video, including average latency, jitter, and packet loss.
- No significant packet drops were observed in either audio or video throughout the test, and all client devices remained connected for the entire duration.

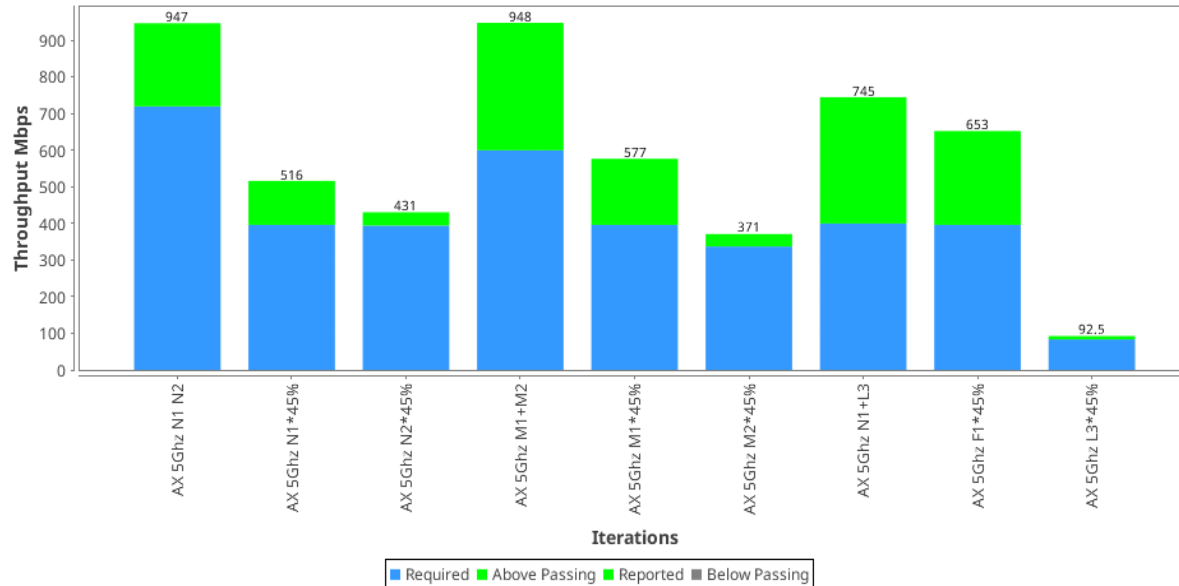
6.2.3 Airtime Fairness Test: AX

With Client connected to 5GHz Band in AX Mode
(80MHz Bandwidth)

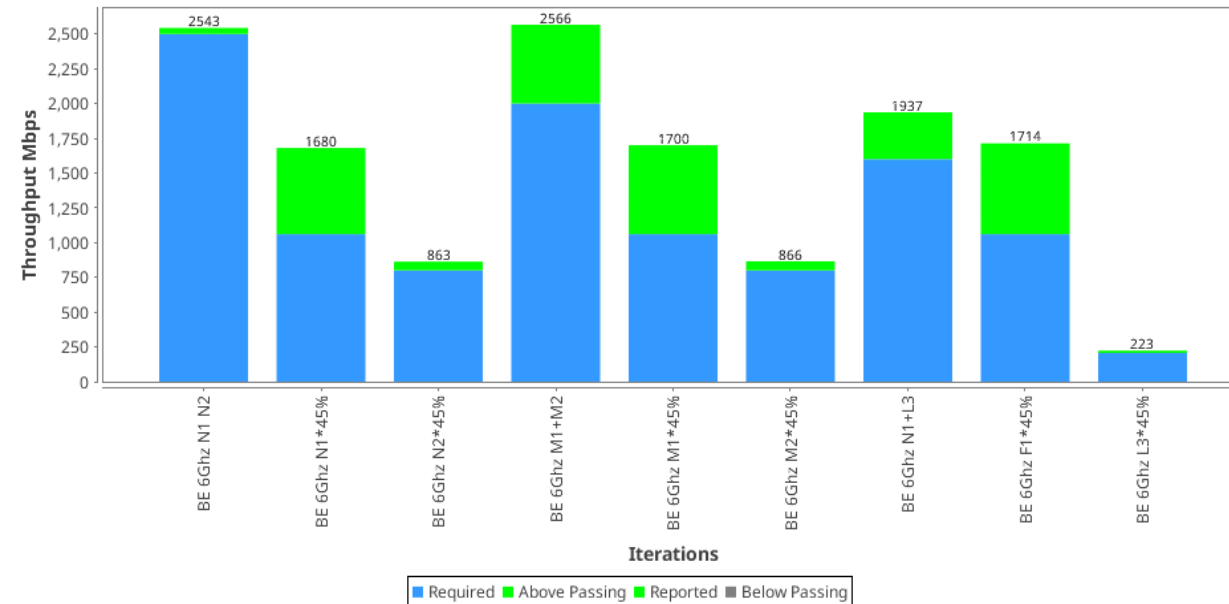
6.2.3 Airtime Fairness Test: BE

With Client connected to 6GHz Band in BE Mode
(320MHz Bandwidth)

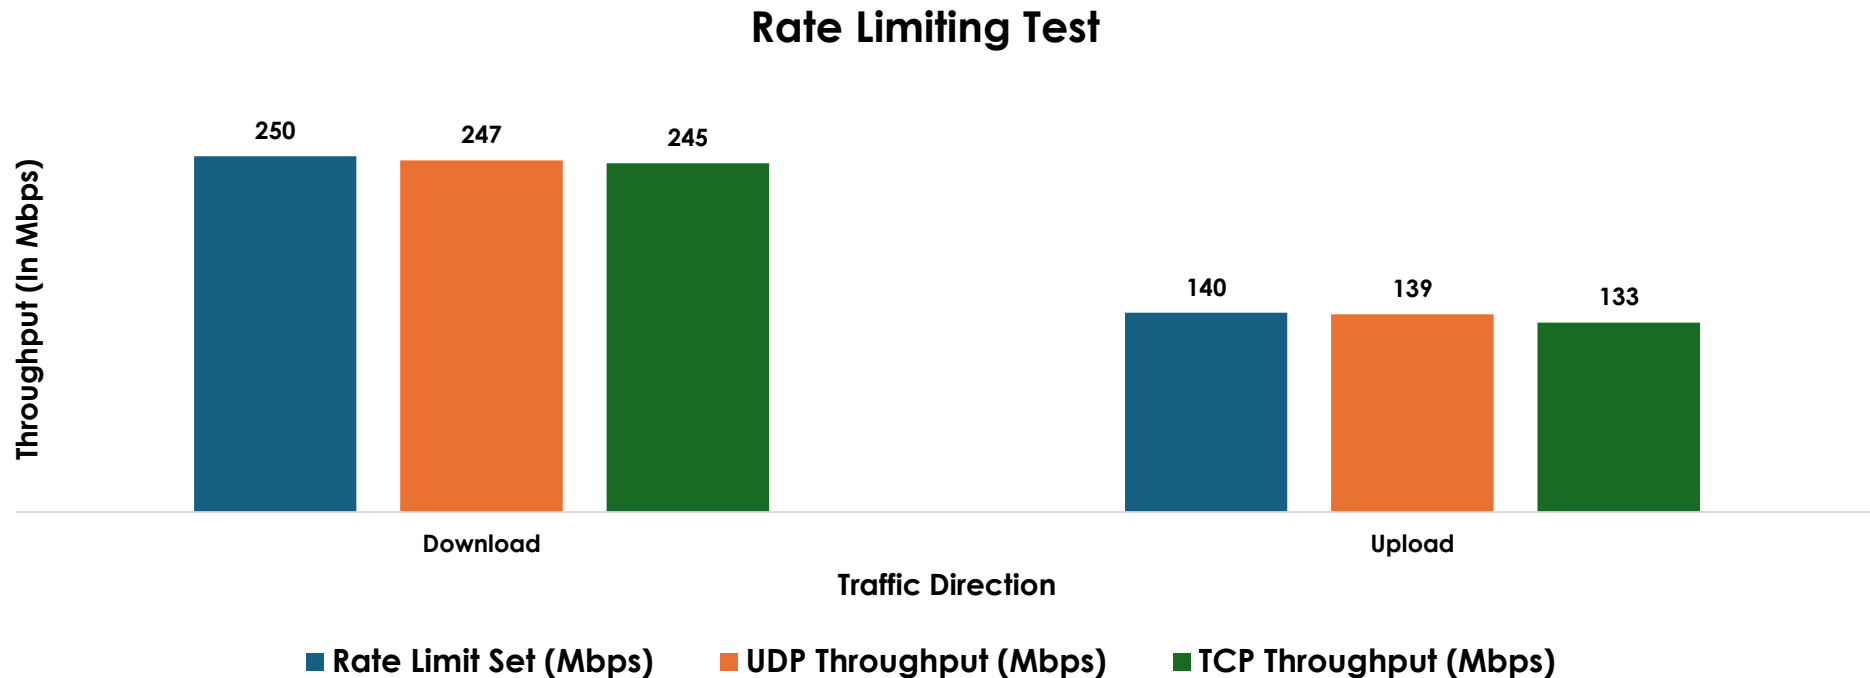
Rate Limiting Test

- Conducted the Rate Limiting test by enabling the rate limiting feature on the AP via the Insight Cloud. The download and upload rate limits were configured to 250 Mbps and 140 Mbps, respectively.
- A client device was connected to the Tri-band SSID, and throughput tests were performed to measure both download and upload speeds using TCP and UDP protocols.
- As expected, after enabling the rate limiting feature on the AP, the client was only able to achieve throughput values below the configured rate limits, thereby confirming that the feature is functioning as intended.

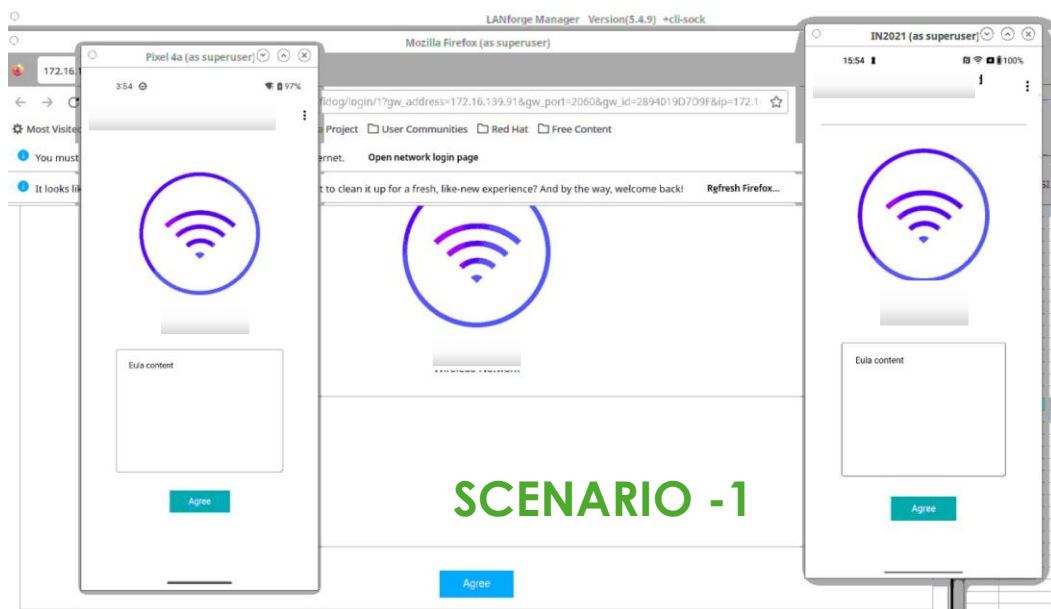
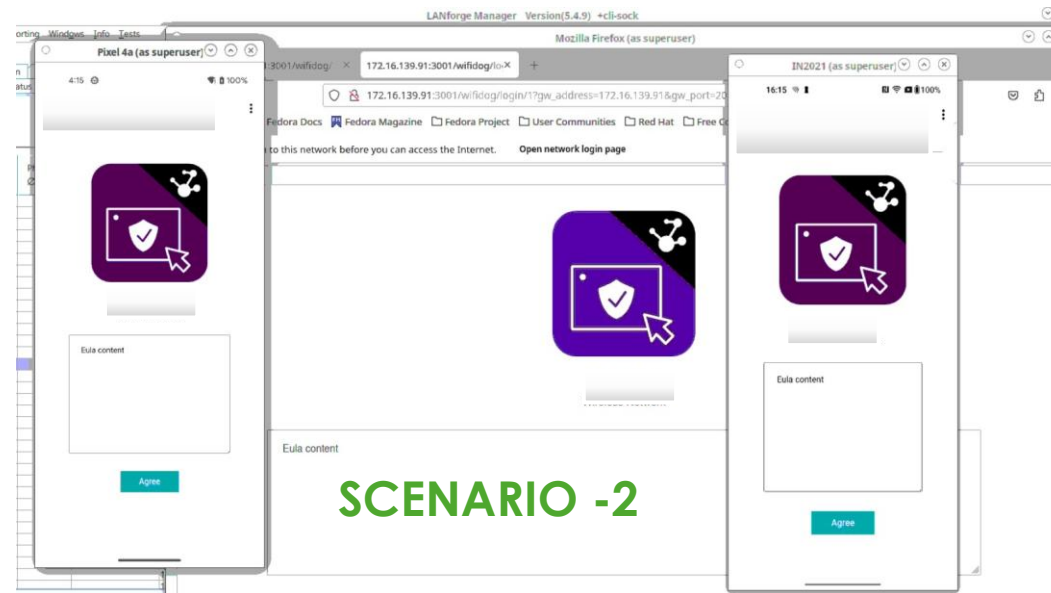
Captive Portal Test

- We conducted Captive Portal testing with a total of 50 clients, including 2 real devices and 48 virtual clients.
- **Scenario 1 – Basic Captive Portal (No Redirection):** A standard captive portal without URL redirection was configured on the Access Point. Upon connecting to the SSID, the captive portal page was displayed correctly on both real and virtual clients. After accepting the terms, internet access was successfully granted to all clients.
- **Scenario 2 – Captive Portal with URL Redirection:** A captive portal with redirection to the splash website and a custom logo was configured on the VENDOR AP Cloud. This scenario also worked as expected. The captive portal page was presented correctly, and users were redirected to the specified URL after accepting the terms.
